HUNTING CREEK DAM

INVENTORY NUMBER NDS MD-58

## PHASE I INSPECTION REPORT

NATIONAL DAM SAFETY PROGRAM

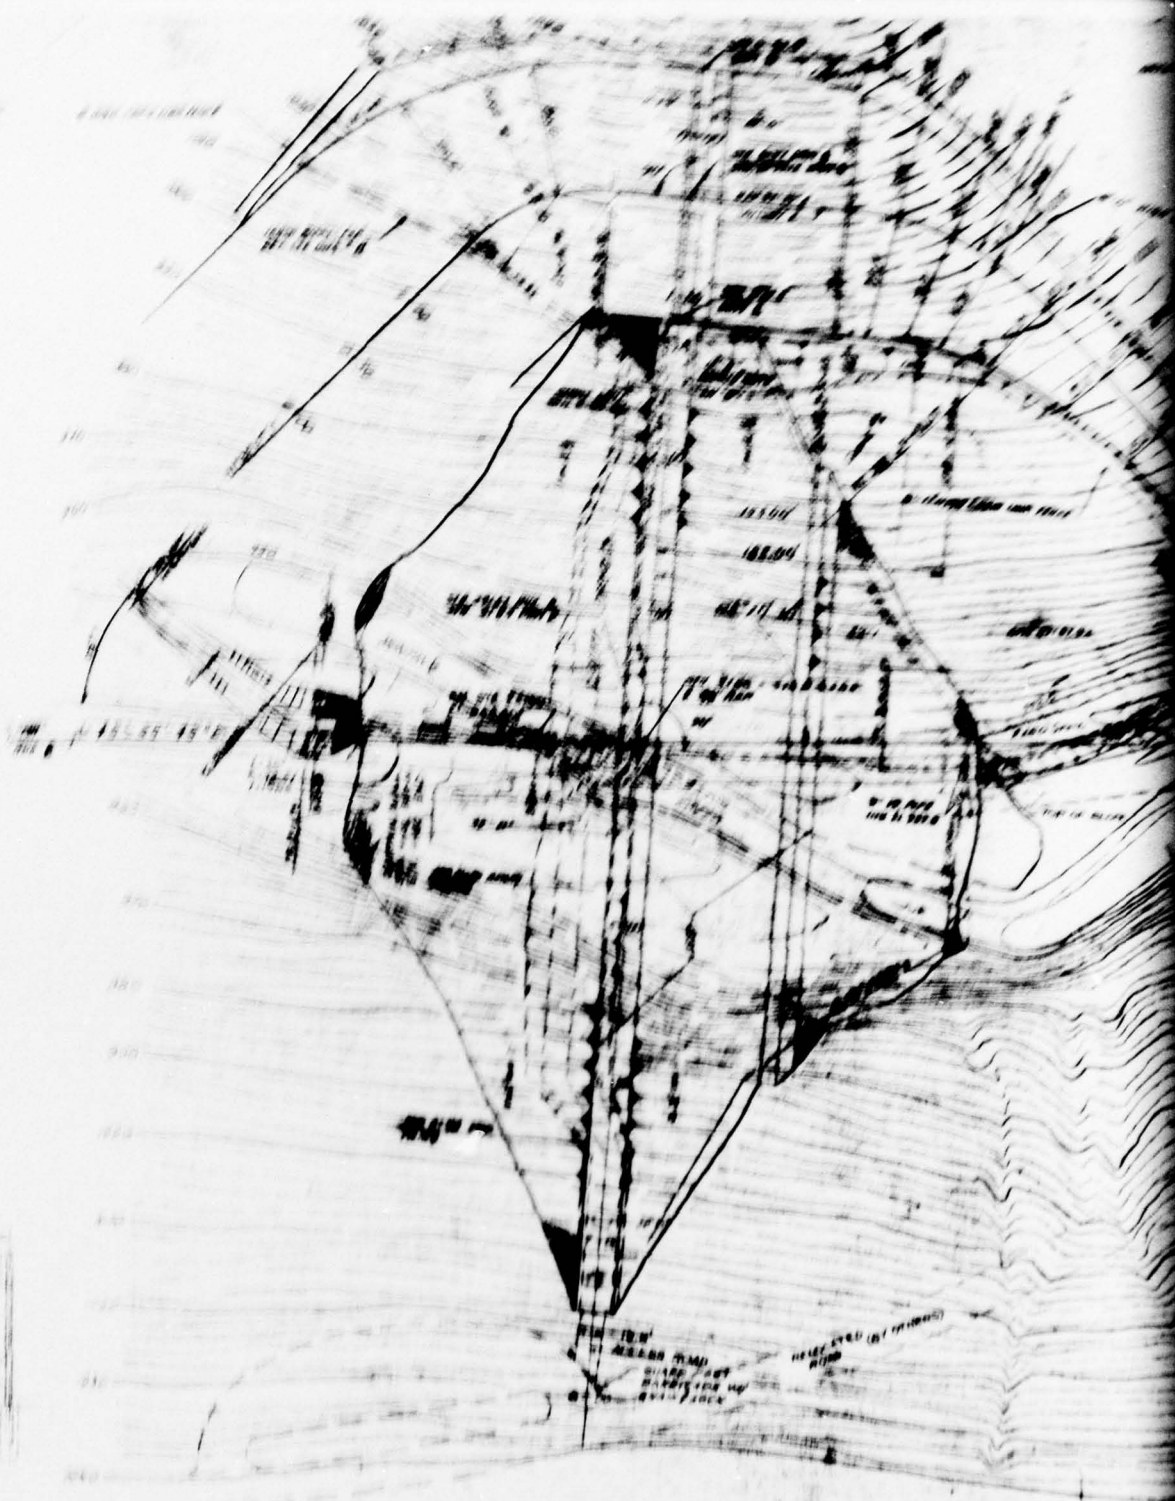
PLATE IV

The spillway channel is excavated into natural rock. Its surface is very irregular and provides a natural energy dissipator for the flow. Some brush and weed growth is located in this channel. The stilling basin is a concrete lined basin located at the end of the spillway channel. Erosion of the rough rock surface has partially filled the downstream end of the basin. The concrete walls of the stilling basin appear to be in good condition. Refer to Appendix D, Plate IV.

The spillway outlet channel contains some brush and weed growth and should be cleared. Also loose eroded materials should be removed.
